# GEOLOGICAL AND GEOPHYSICAL TESTS TO MODEL A SMALL LANDSLIDE IN THE LANGHE HILLS

Sabrina Bonetto<sup>(1)</sup>, Cesare Comina<sup>(1)</sup>, Andrea Giuliani<sup>(1)</sup> and Giuseppe Mandrone<sup>(1)</sup>

**Abstract** In April 2009, North-West Italy was interested by heavy rainfalls that triggered several landslides, especially of shallow type, and caused relevant rise of water level in many rivers, in some cases even beyond the alert level. Particularly in the hills near Alba (NW Italy), many landslides occurred, most of them belonging to the debris flow or soil slip types. In this area, a small but interesting landslide involved a local road and a high quality, recently planted, vineyard. The present study shows the use of different disciplinary approaches focused to understand the behaviour of this landslide: in particular, besides geological and geomorphologic studies, detailed topographic and geophysical surveys together with an in situ geotechnical/geomechanic characterization were applied. The combined interpretation of the different techniques and of field observations allowed to define a geological and technical model of the landslide, both in surface than in depth, t

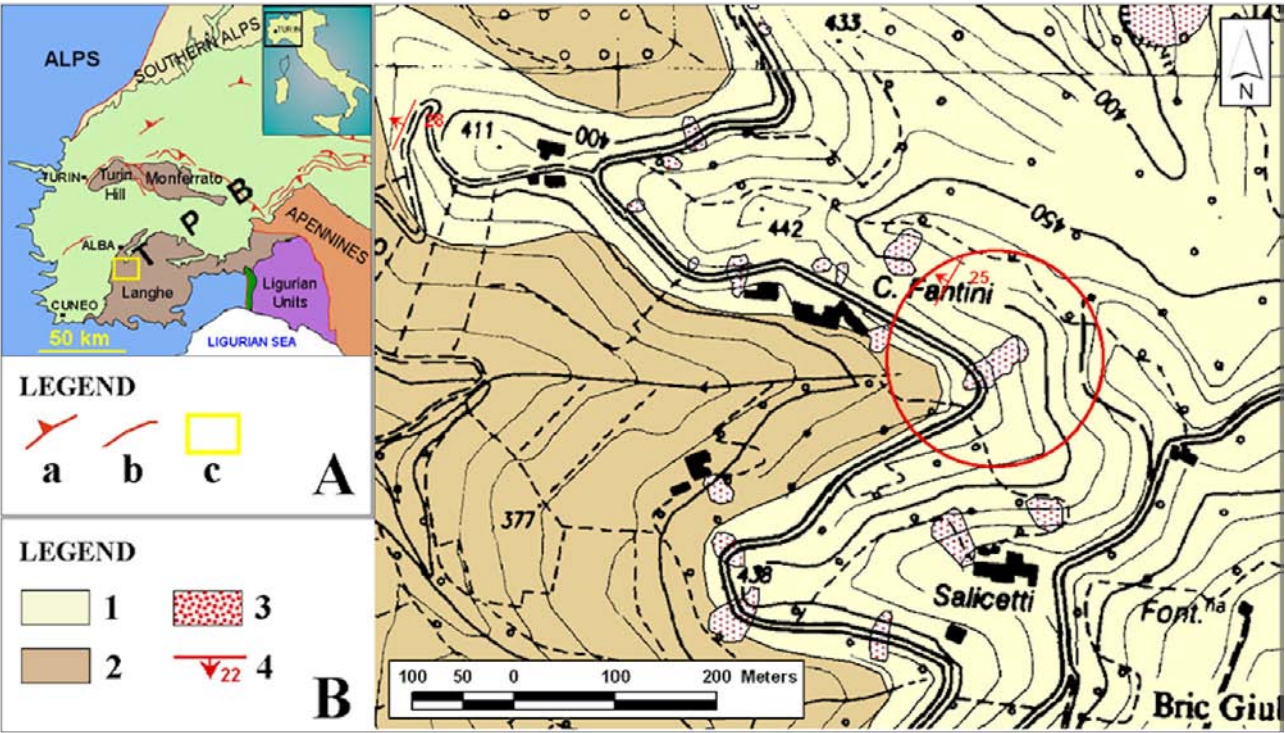
Figure 1

Fig.1 - Location map and geological setting of the study area. A) geological sketch map of Tertiary Piedmont Basin (TPB): a - thrust fault, b – fault, c - study area; B) geological setting of the study area: 1 - Diano d'Alba Sandstones F., 2 - Sant'Agata Fossili Marls F., 3 - recent landslides occurred in April 2009, 4 - strike and dip of beds. The studied area is marked by a red circle.

The study area is located in the southern Piedmont's hilly territory (Langhe), near Alba (fig. 1A). The geology is represented by sedimentary units mainly composed of terrigenous successions of interbedded layers of sandstone, marls and siltstone which are shaped with a typical "cuestas" morphology.

The studied area (fig. 1A) belongs to the Tertiary Piedmont Basin (Gelati and Falletti, 1996). This sequence forms a gentle NW dipping uplifting structure, characterized by “cuestas” morphogenesis carried out by fluvial erosion. Indeed, the hills of the Langhe are characterized by asymmetrical slopes that range from 25° to 40° towards SW and from 10° to 25° towards NW.

Two geological formations characterize in detail the studied area (fig. 1B): the Diano d’Alba Sandstones Formation at the top of the hill, and the S. Agata Fossili Marls Formation, in the lower part of the slope. The former is represented by sand and sandstones dark-grey or yellowish coloured, some metres thick, interbedded to clayey-sandy marls, some decimetres thick. The latter is characterized by marls and clayey-marls, blue-grey coloured. These formations are usually considered as impermeable, but a remarkable water circulation takes place during heavy or prolonged rainfalls within the coarser levels and/or within the less cemented ones. The bedrock coverage is usually very thin (less than half meter) and characterized by silts and fine sands.

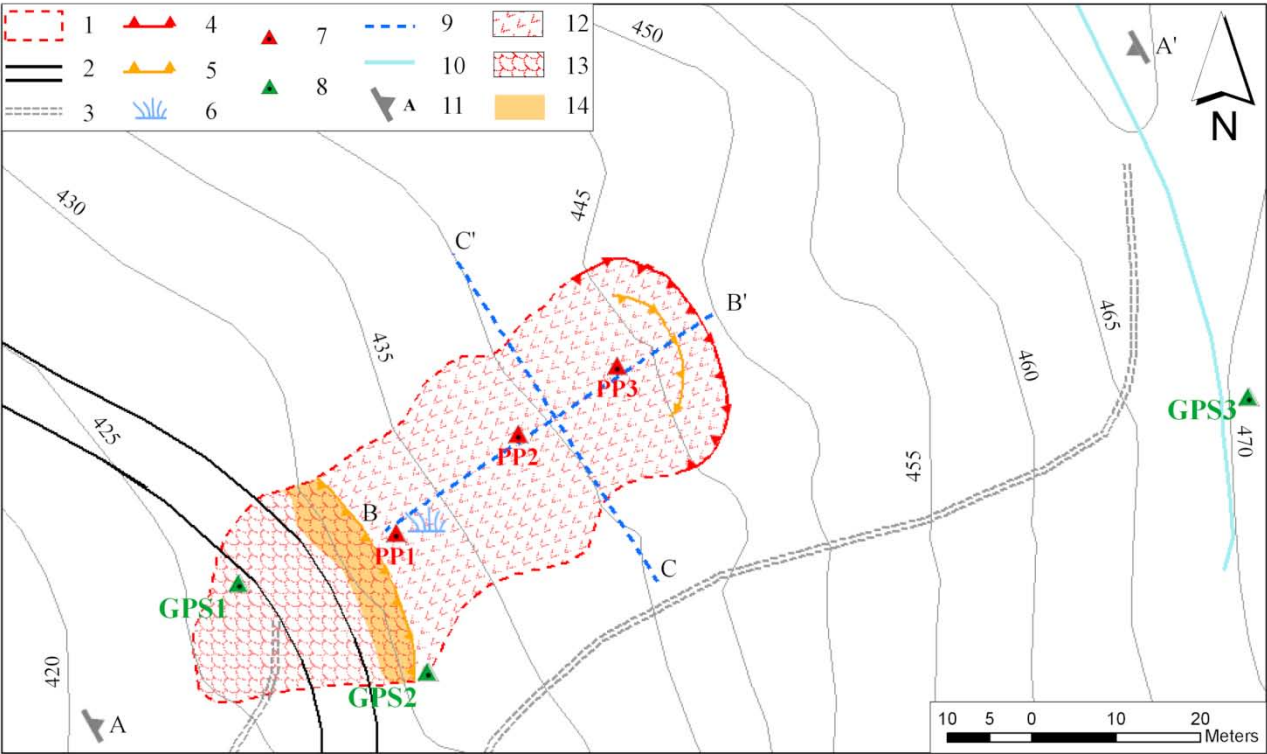
Figure 2

Fig.2: Details of the landslide and of the field investigations: 1 - landslide borders, 2 – road, 3 – track, 4 - main scarp, 5 - minor scarp, 6 – water impoundments, 7 - dynamic penetration test sites, 8 - GPS ground control point and total station bases, 9 - geophysical arrays, 10 - trace of geological section, 11 - slide, 12 - flow, 13 - man-made slope.

The landslide involved a concave slope dipping SW of about 20° which is cut by a road just at the bottom (fig. 2 and 3). After the event, a field survey was carried out on the area: preliminary surface observations pointed out two scarps, at the top of the landslide area, with height of about 1 m each. Using a total station, a more detailed topographic survey investigated the landslide and a significant area around it, allowing to define the morphometry after the failure. Georeferentiation was obtained using information from accurate location of ground control points during post-processing elaborations. These points (3 stations) were collected through a GPS device (dual frequency, dual-constellation RTK GPS, 24 GPS + 11 GLONASS Satellites with fully integrated receiver/antenna). Data elaboration was carried out by a GIS system to relate the collected data with the following digital thematic cartographies.

Two different geophysical methods were applied: respectively, electric and seismic tomography (concerning both P and S waves velocities) along the major and minor axis of the ellipse drawn by the border of the landslide (for location, see fig. 2).

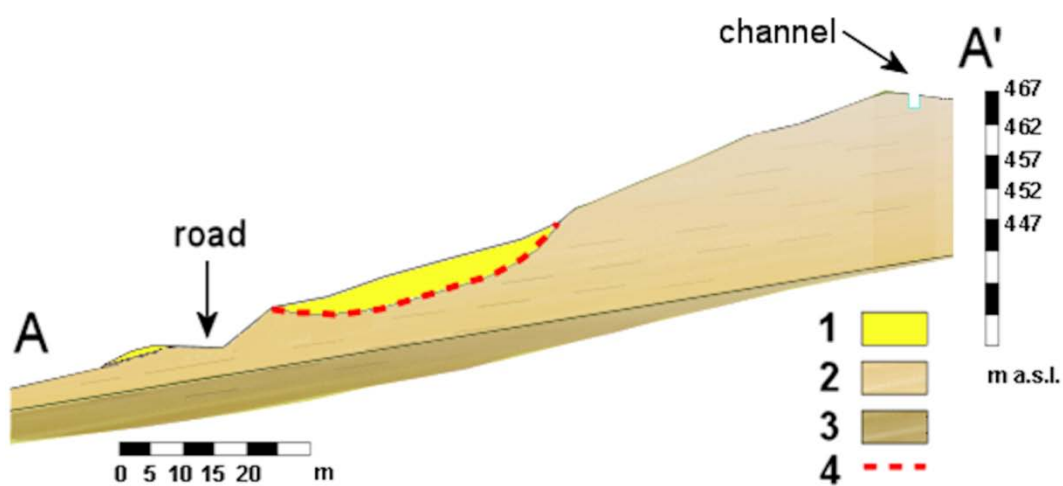
Figure 3

Fig.3: Longitudinal section of landslide (for location see Fig 2): 1 - displaced material; 2 - Diano d'Alba Sandstones F.; 3 - Sant'Agata Fossili Marls F.; 4 – sliding surface.

Just on the other side of the hill, a man made trench was observed (fig. 3). This trench acts as agricultural channel and collects water from houses and fields located to the E of the study area; due to the abundant rainfalls of the days immediately before the sliding, it should be almost full when the slope failed.

The multidisciplinary approach used for this small landslide allowed to reconstruct a detailed geological model. Fig. 3 and 8 show the conceptual model of the slope according to geological surveys, which was confirmed by the subsurface investigations. The landslide involved a flysch-type bedrock; it moved - at the top - as a rotational slide, and - in the middle part - as a translational one. The mobilized material turned into a debris flow that swept the road and part of the slope below.

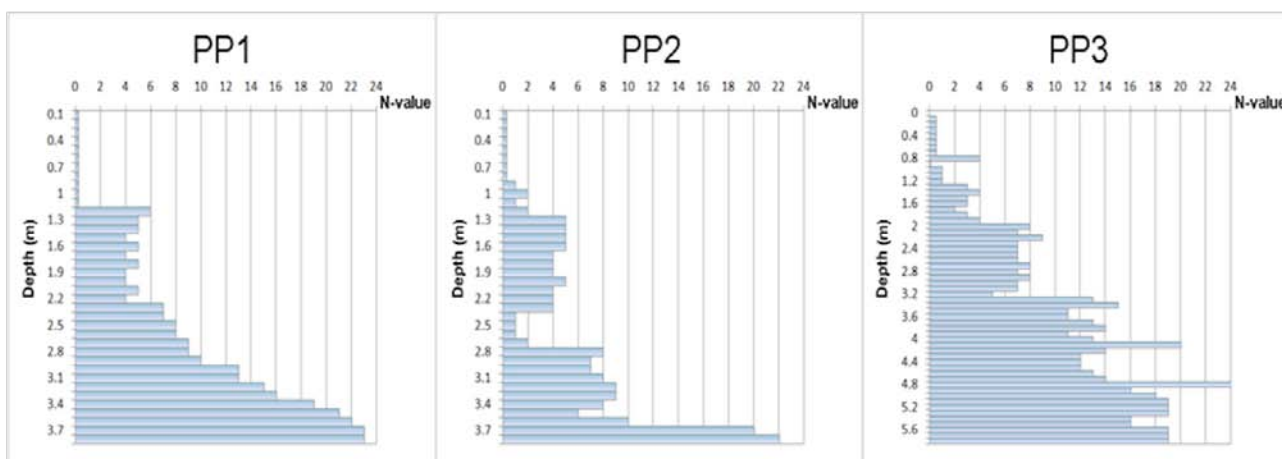
Figure 4

Fig.4 Technical profiles of the dynamic penetrometer tests.

Geotechnical surveys were done some days after the landslide event. For in situ surveys, a light dynamic penetrometer was used with 30 kg weight hammer falling from a height of 20 cm. Three tests (PP1, PP2 and PP3) were carried out in the central part of the main body of the landslide, along a line also used for geophysical surveys (fig. 2), in order to verify the state of the subsoil (according to the mechanical resistance) and to obtain approximate location of the sliding surface.

The results of the three surveys are reported in fig. 4. All tests revealed a general increase in soil density with depth. First change is evident at 0.8 – 1 m of depth, probably in correspondence of the soil-subsoil transition. However, at this depth, a still low subsoil resistance is noted; an abrupt change in penetration resistance can be instead observed at about 3-3.5 m of depth, where the bedrock was probably reached.

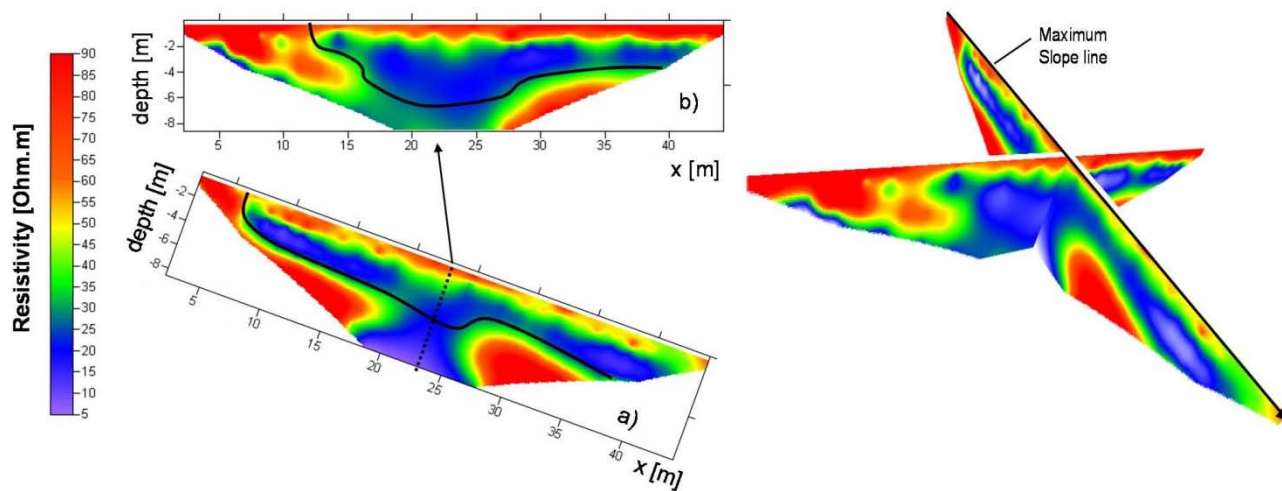
Figure 5

Fig.5 Electric topographies, executed a) longitudinal (B'-B) and b) transversal (C'-C) to the slope, and probable position of the sliding surface (thick black line). On the right, a combined view of the two sections.

Electric tomographies were acquired with two different spreads of 32 electrodes with 1.5 m electrode spacing deployed along the B-B' and C-C' lines, to provide an image of the slope in both directions. The acquisition used a PASI tomograph and a Wenner-Schlumberger measuring sequence; with such a sequence, it is indeed possible to obtain a good compromise between both vertical and lateral resolution. Due to the relatively shallow expected sliding surface, reduced arrays length were used allowing for an investigation depth of about 10 m. Acquired data were inverted by the commercial inversion code Res2Dinv® (Loke and Barker, 1996).

The results of the two electric tomographies are shown in fig. 5. A very shallow (1 – 1.5 m) dry layer overlying a zone of reduced resistivity can be noticed. This zone is located inside the sliding body and is probably related to porous wet material. At the bottom of this high-conductivity zone, evidence of an increase in resistivity can be related to the contact between the landslide body and the bedrock. A very good coherence in the results of the two surveys can be observed, particularly in the overlapping central zone where both images underline a decrease in resistivity in the central part of the slope. This can be explained by the presence of preferential flow path that can have favoured the sliding movement. Indeed, field evidence underlined the presence of a significant amount of water in this area right after landslide activation.

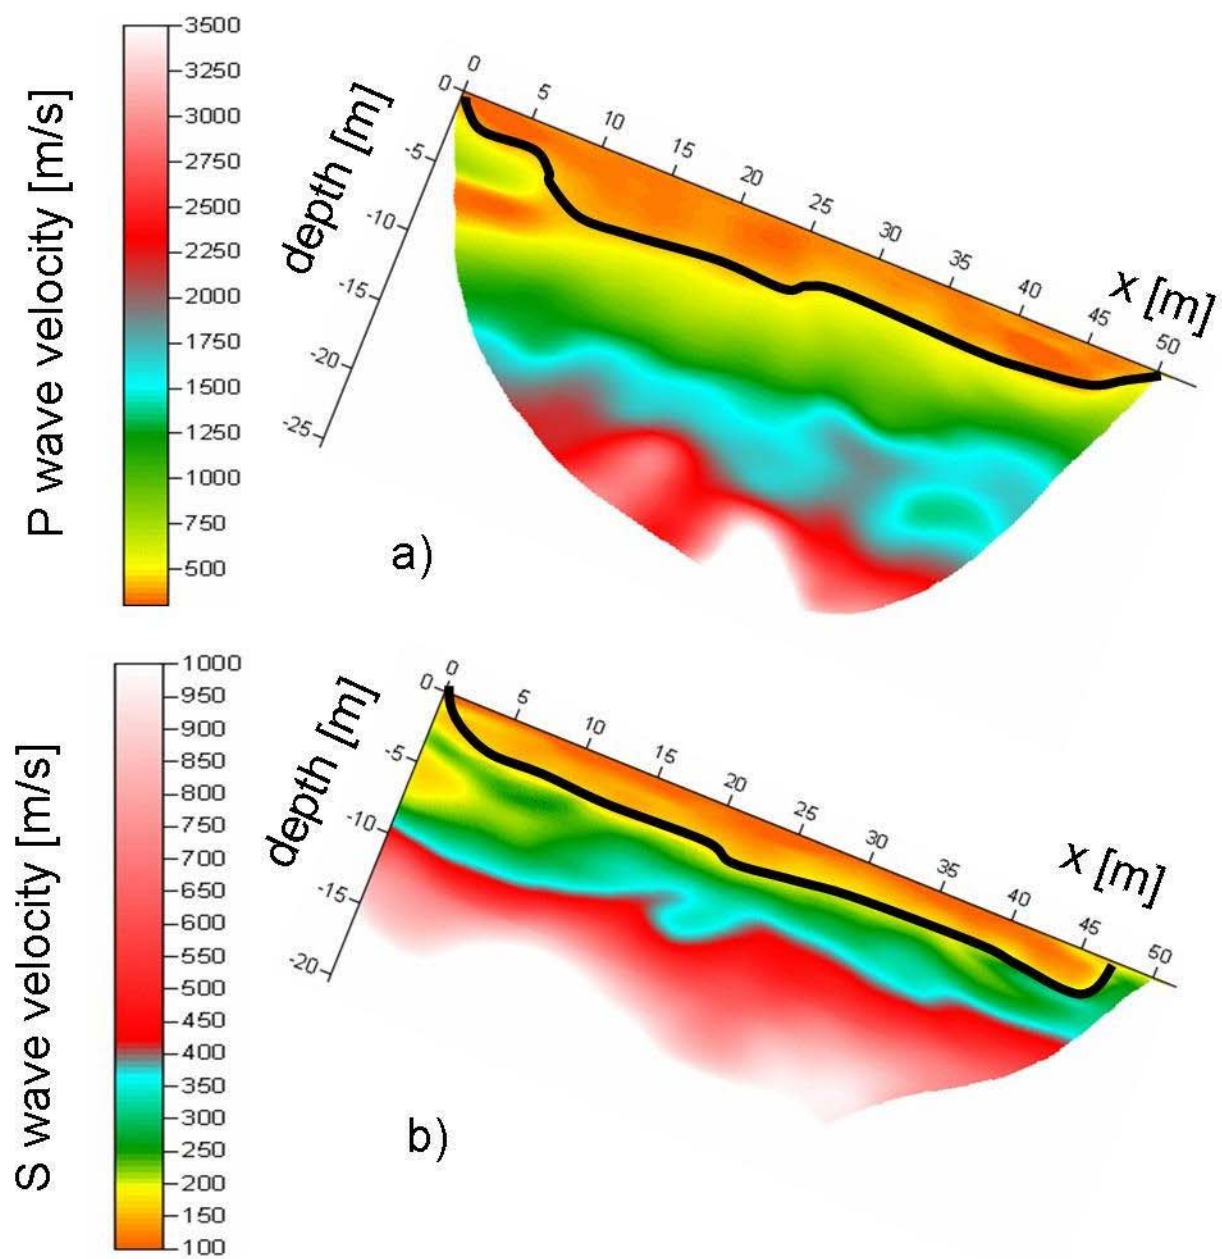
Figure 6

Fig.6 - Seismic P wave tomography and seismic S wave tomography executed longitudinal (B'-B) to the slope with probable position of the sliding surface (thick black line).

Seismic tomographies were performed only along the maximum slope line (B-B' line) but, in order to retrieve both S and P wave velocities, different sources and sensors were used. For P waves, an array of 24 vertical 4.5 Hz geophones with 2 m spacing and a vertical hammer source were used; for S waves, an array of 24 swyphones<sup>tm</sup> (Sambuelli and Deidda, 1999) with 2 m spacing and an appropriate SH source were adopted. Different shot positions were used along the survey line in order to have adequate data for tomographic interpretation. Both arrays were acquired with a Geometrics Geode Seismograph and interpreted for tomography with the commercial code Rayfract®. The use of swyphones<sup>tm</sup> allowed a reduced time acquisition since no inversion of the source was necessary. The measuring techniques for S wave velocities usually require a more complex acquisition, which are particularly difficult to be attained - especially in complicated logistical conditions such as the ones that commonly characterize landslide sites.

With respect to seismic tomographies, in fig. 6 the results of P and S wave tests are shown. From both images, a clear evidence of the contact between the displaced material and the stable rock can be evidenced, helping to delineate the sliding surface. The P wave tomography seems to identify the presence of a low water table (around 15 m depth for P wave velocities of 1500 m/s). This is coherent with previous data in the area since the tests were executed some times after the rainfall events, and a requilibration of the water level probably occurred. In this respect, the results of the electric tomographies can be reinterpreted by excluding the presence of saturated material near the surface, and by attributing the decrease in resistivity to wet material with some clay content (cf. grain size distribution curves). Due to the increased sensitivity of shear waves to the soil skeleton properties, the S wave tomography is instead more able to delineate the variations in the structure of the soil near the slope. Indeed, the presence of a reduced velocity zone just in the middle of the slope is highlighted. The position of this zone is very coherent with the reduced resistivity of the central portion of the slope body, and can be related to loose material which favoured the water flow in the slope.

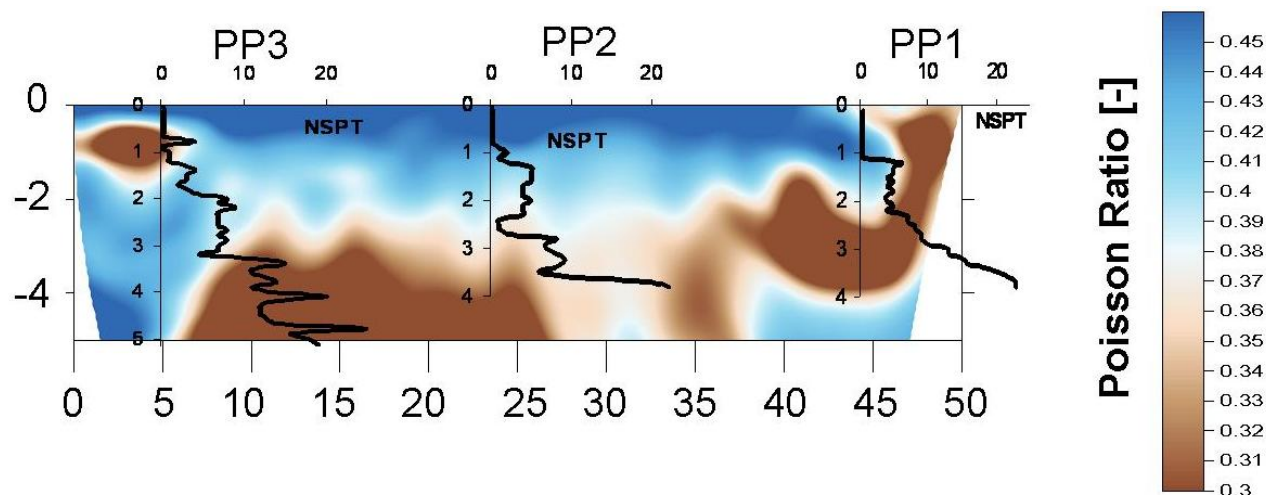
Figure 7

Fig.7 - Poisson ratio map in relation to of penetrometer tests along the major axis of the landslide.

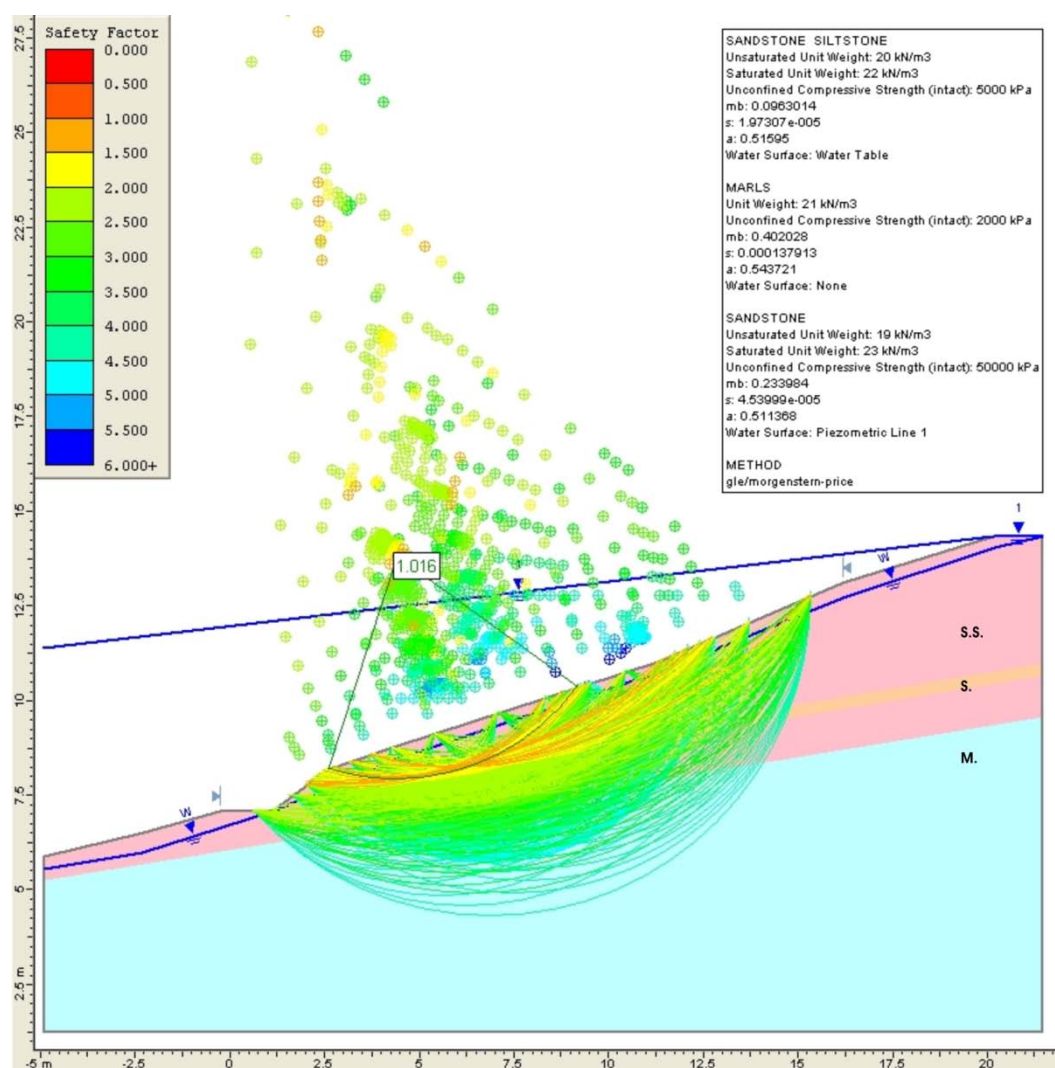
Figure 8

Fig. 8 – Slope stability analysis with minor safety factor value coherent with measured sliding surface. Keys: S.S. = sandstone and siltstone, S. = sandy level, M. = marl, w = water table in S.S., l = pressured water table in S.

In particular, we were successful to reconstruct the observed sliding surface introducing the following characteristics: 1) a high permeable sandy level below the landslide, where the wet level is located, implemented the simple geology of the slope; this level is probably connected to the channel at the top of the hill thanks to the jointing of the rock mass in that area, 2) a free water table in the Diano d'Alba formation close to the surface ("w" in fig. 8), 3) a pressured fast water circulation in the sandy level ("1" in fig. 8) fed by waters in the channel at the top of the hill. As a matter of fact, the main triggering mechanisms for this small landslide had both natural and man made origin. According to field evidence and using this conceptual model, back analysis allowed to obtain a good correspondence in terms of sliding surface.
